## ***Engineering Report***

**NuTech Orchard Removal, LLC**

**DuraTech Industries International, Inc.**

*Prepared by:*  
John A. Thomazin, P.E.  
Forensic Engineering Technologies, LLC  
3626 Quadrangle Boulevard, Suite 200  
Orlando, Florida 32817

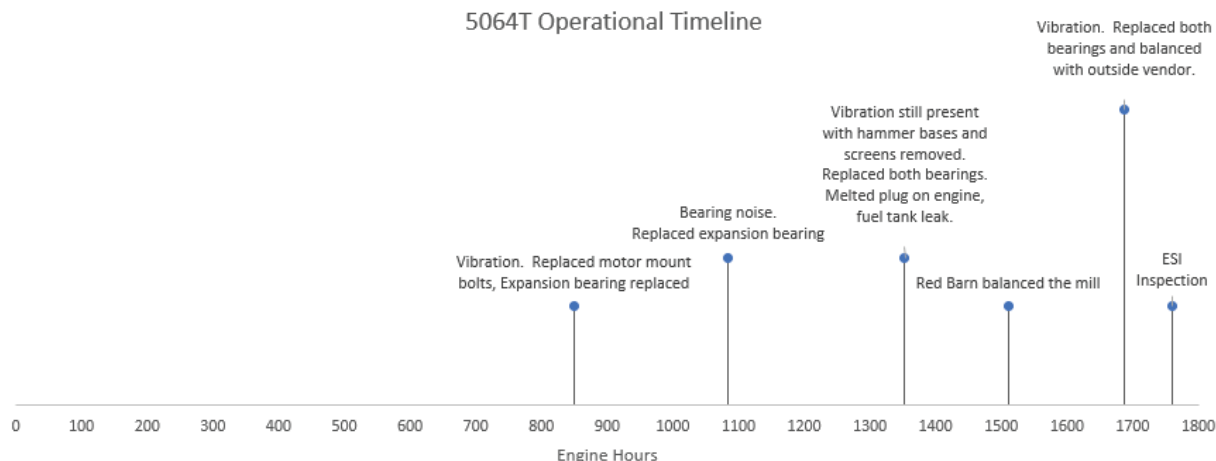
Figure 1: Timeline showing operational repairs versus engine hours.

- Thereafter, replacement bearings began failing at much shorter intervals: 235, 269, and 334 hours respectively for the non-pulley-side bearing (Figure 1). The life of a bearing averaged approximately 280 hours or about one-third the life of the original part. The pulley-side bearing was replaced at or near the same time that the non-pulley-side bearing was replaced.

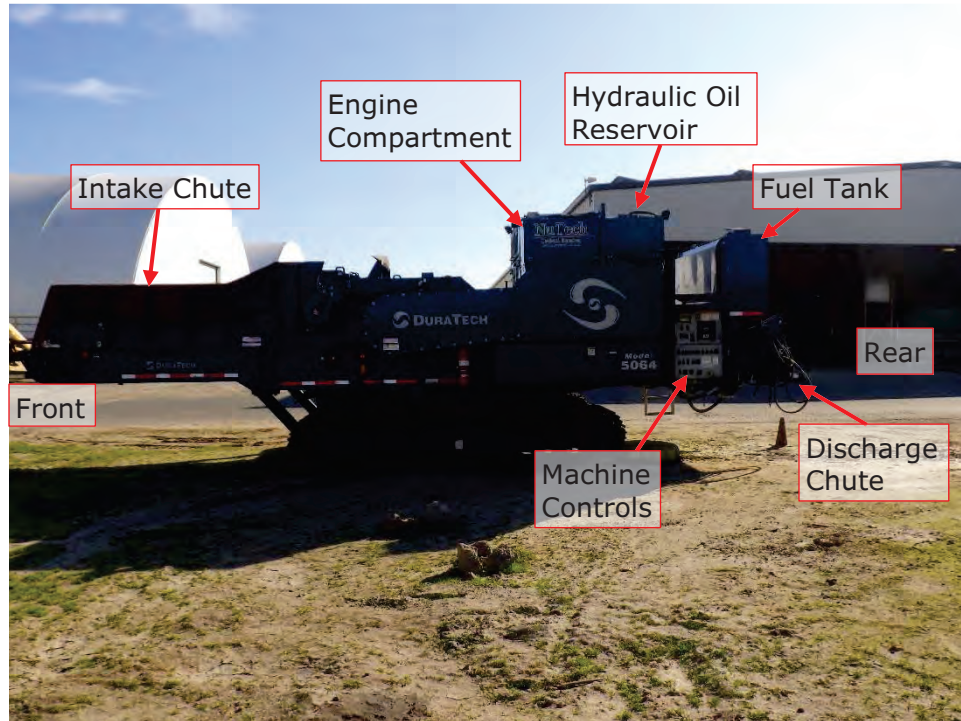
*Figure 2: Photo of the 5064T grinder showing relative locations of various components on the pulley side (right) of the grinder. The rotor bearing on this side of the grinder is fixed.*

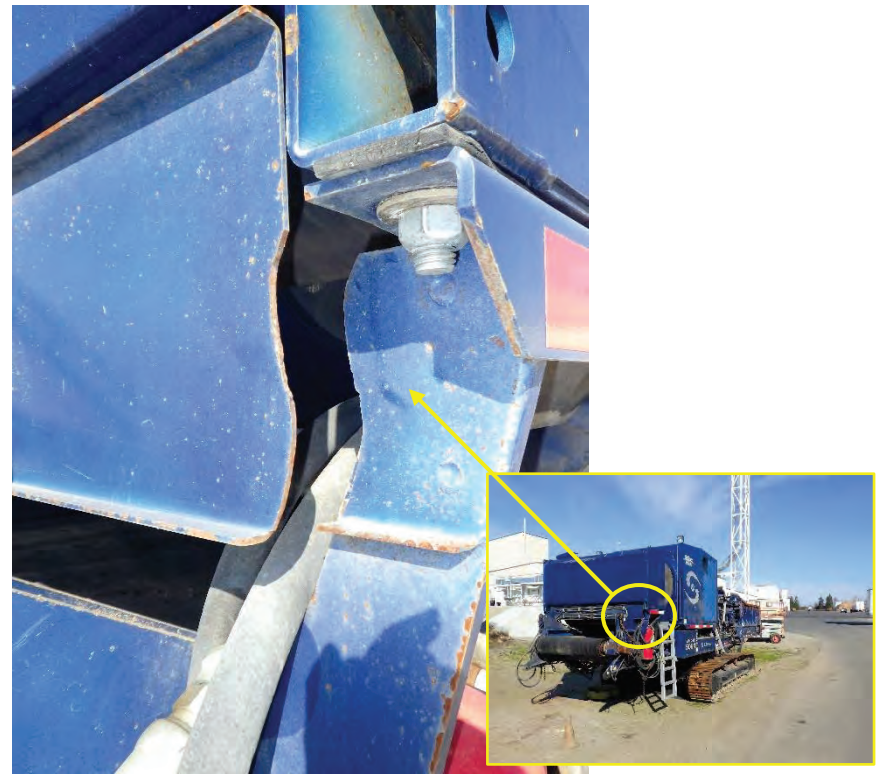
Photo shows a fracture in a bracket below the fuel tank. Inset shows the relative location of the fracture on the grinder.

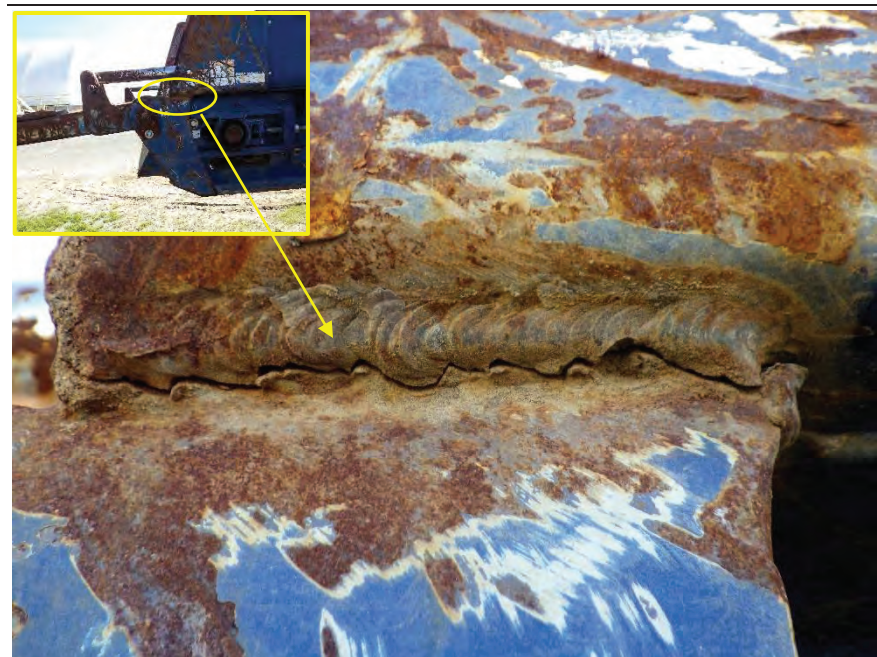
Photo shows a fracture through a welded joint connecting the front table assembly to the grinder's frame. Inset shows the relative location of the fracture on the grinder.

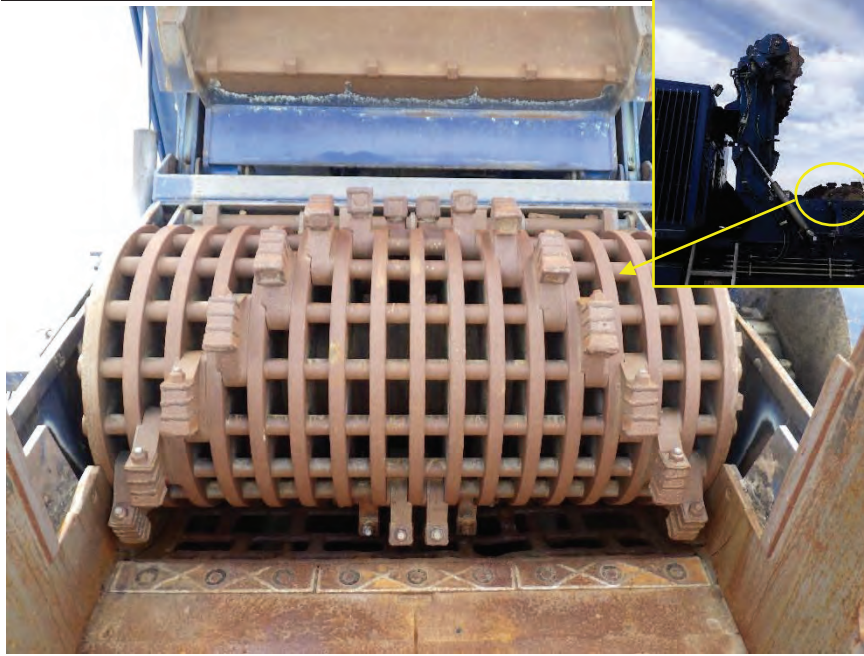
Photo shows the hammer mill/rotor. Inset shows the location of the hammer mill and feed roller in the open position.

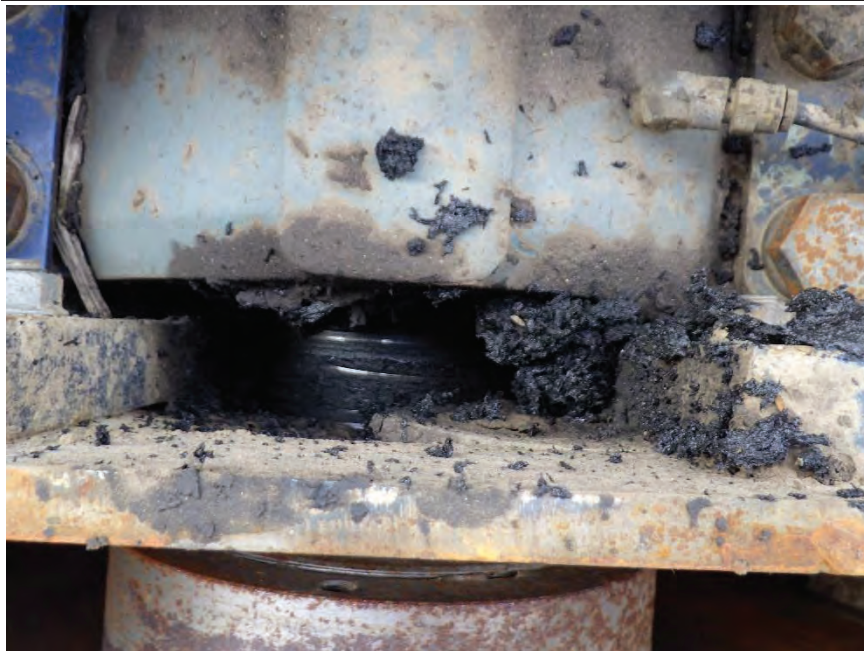
- Rotor bearings had been greased. Grease was expelled through the seal.
- The track assembly is fastened directly to the framework of the grinder.
- The rectangular screen in the grinder was fretted.
- Rotating the rotor by hand was laborious. The rotor didn't spin easily.
- Counterbalancing weights had been removed and added to the rotor.

Photo shows grease spun around the rotor's bearing.

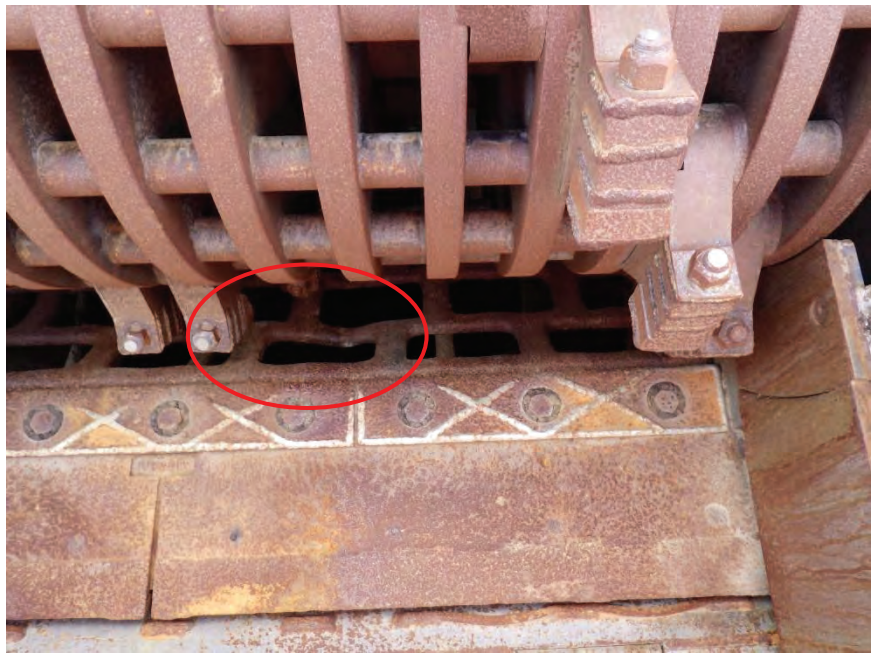
Photo shows the screen is damaged.

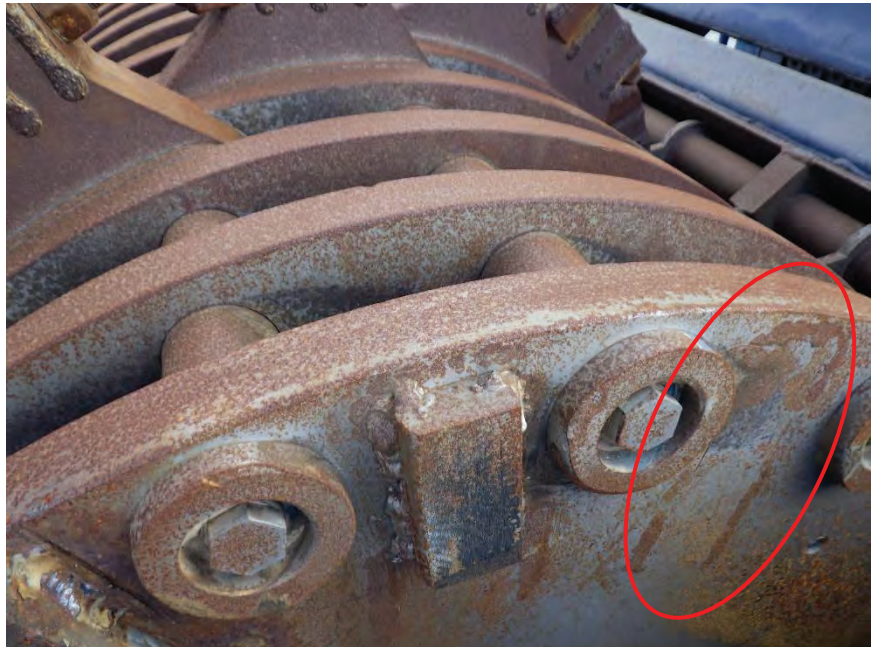
Photo shows counterbalance weights attached to the rotor. Red oval marks the location where a weight was removed from the rotor.

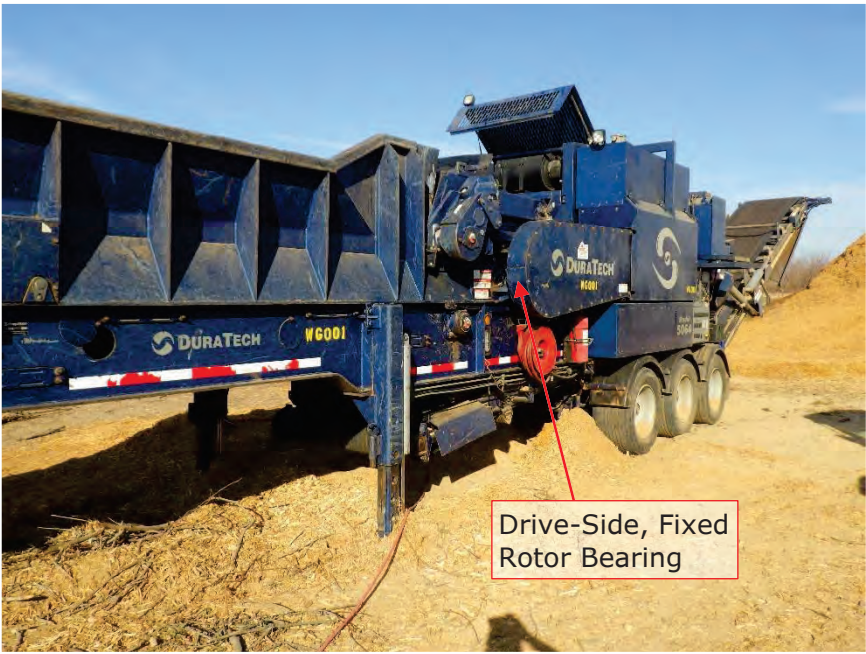
<p>Drive-Side, Fixed Rotor Bearing</p>	Photo shows the right side of the exemplar 5064 grinder. The fixed bearing is located on this side of the grinder.

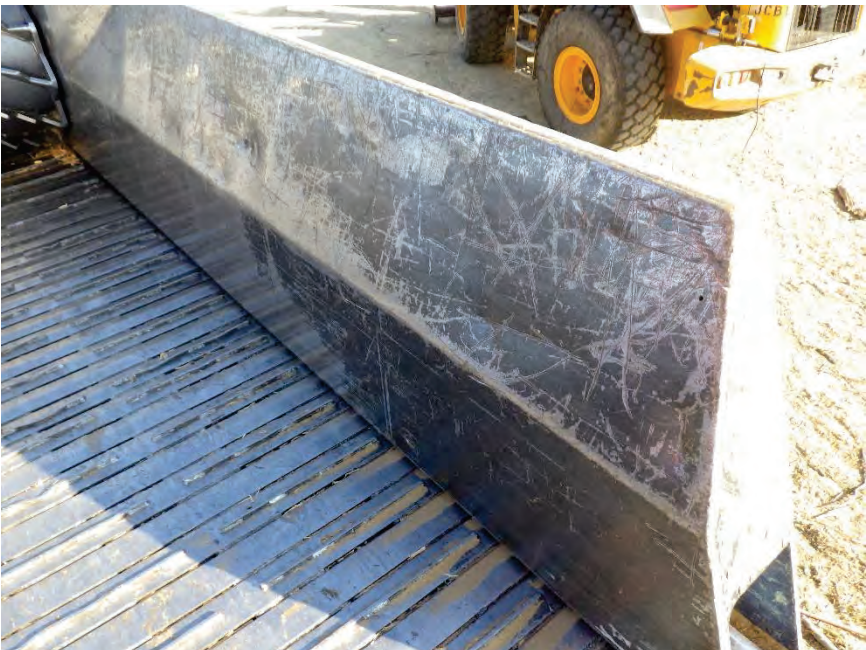
Photo shows the sidewall of the chute.

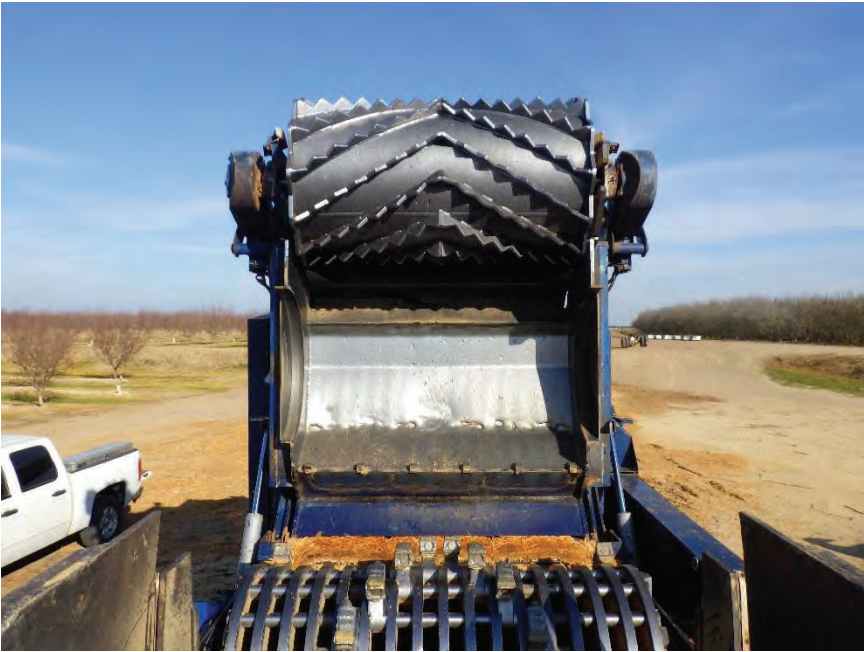
<p>Photo shows the feed roller locked in the up position.</p>
